BROCKWAY SUMMIT FILL SLOPES REPORT

May 2008

INTRODUCTION

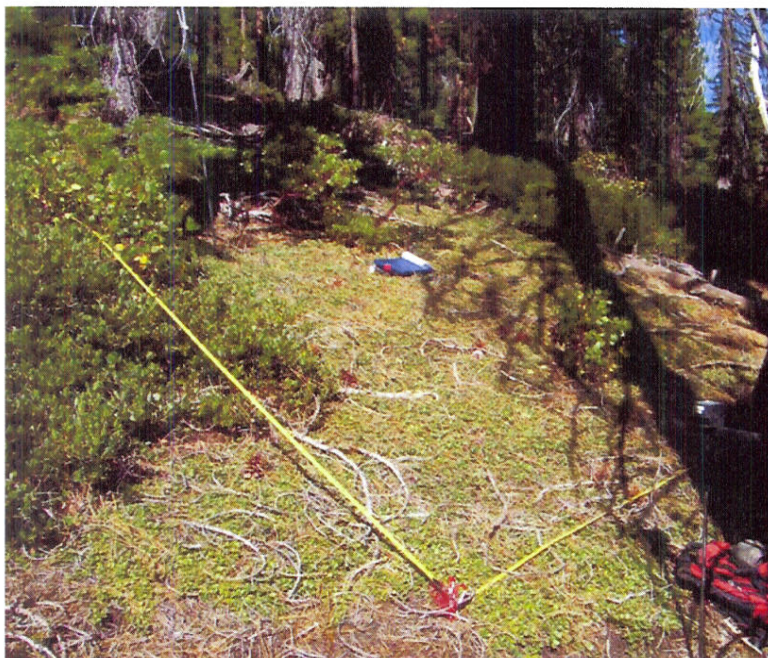
Figure 3. Brockway Summit native reference site. Squaw carpet (*Ceanothus prostratus*), greenleaf manzanita (*Arctostaphylos patula*), and huckleberry leaf oak (*Quercus vaccinifolia*) are the dominant species.

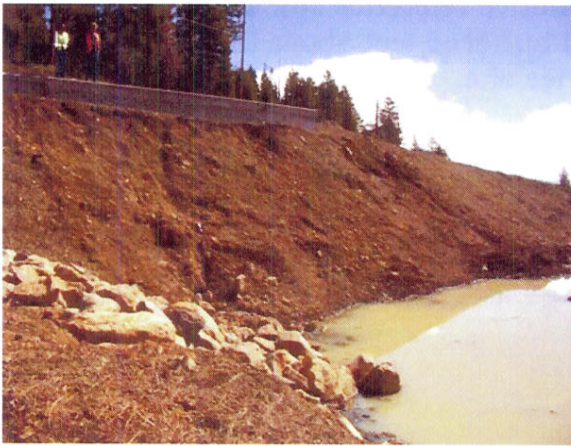
In 2004, after slope failures, the Brockway Fill Slopes received varying restoration treatments (Figure 4). Failures continued at the no till treatment in Basin #3 directly after treatment (due to a concentrated flow from the road) and repairs were made in 2005. There have been no failures at any of monitored plots since 2005. Figure 5 shows the Brockway Fill Slopes Basin #1 following the 2004 treatment. Figure 6 and Figure 7 show the plots tilled to 12 to 18 inches and the plots without tilling at Basin #3 in 2006. When utility work was conducted at the basins, wheatgrass was seeded after disturbance.

Figure 4. Brockway Summit Fill Slope basin, pre-treatment, 2004.

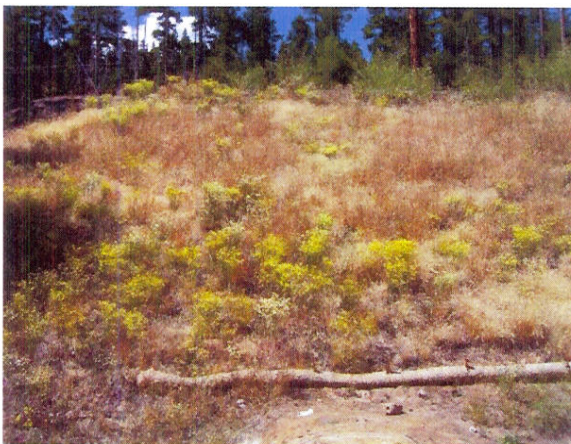
Figure 6. Basin #3, 12 to 18 inch till treatment, 2006.

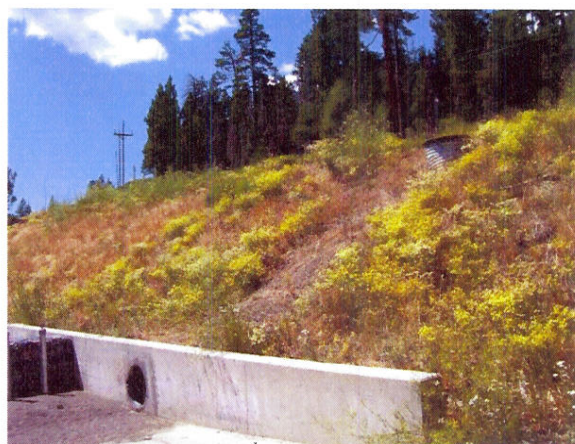
Figure 7. Basin #3 treatment, no till treatment, 2006.

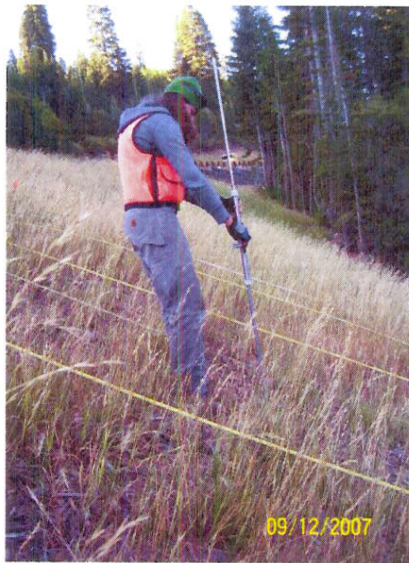
Cover was measured using the cover point method along randomly located transects.¹ The cover pointer consists of a metal rod with a laser pointer mounted 3.3 feet (1 m) above the ground. After the rod was leveled, the button on laser pointer was depressed and two cover measurements were recorded (Figure 10 and Figure 11):

Figure 10. Cover pointer in use along transects.

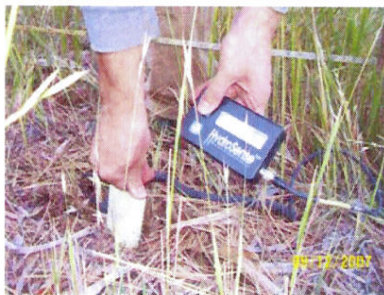
A hydrometer was used to measure volumetric soil moisture content adjacent to the penetrometer readings at a depth of 4.7 inches (12 cm) (Figure 14).

Figure 14. Conducting soil moisture readings along transects.

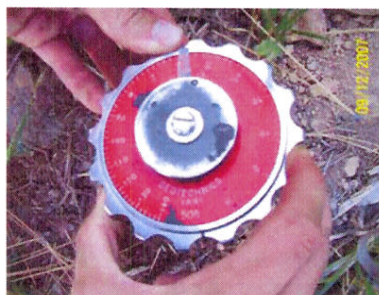
In 2007, soil strength was tested along cover point transects in the same manner as soil density and soil moisture. A hand-held shear vane with 1.5 inch (3.8 cm) long blades was pushed into the soil to a depth of 3 inches (7.6 cm) and turned until the soil could no longer resist the force exerted by the blades and the soil structure either fractured or deformed (Figure 15). This force was then recorded as the “shear stress” in kilopascals (kPa). Forty kilopascals is the maximum force the shear vane can measure. Shear stress values greater than 40 kPa were recorded as 40 kPa. The shear vane was used at both the compost till and the compost no till plots at Basin #3, but only at the compost till plot at Basin #1. The soil at the no till plot at Basin #1 was too dense to allow insertion of the blades into the soil.

Figure 15. Soil shear strength tester in use.

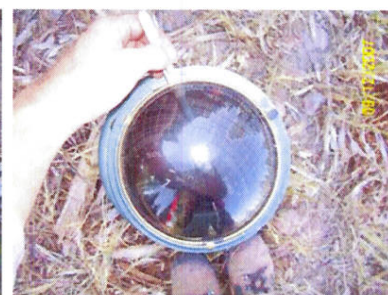
Solar input was determined using a Solar Pathfinder (Figure 16). Solar input affects evaporation rates and soil temperature, which may affect time of seed germination, germination rate, rate of plant growth and soil microbial activity. It is an important variable to consider when monitoring plant growth, and soil development.

Figure 16. Solar pathfinder in use.

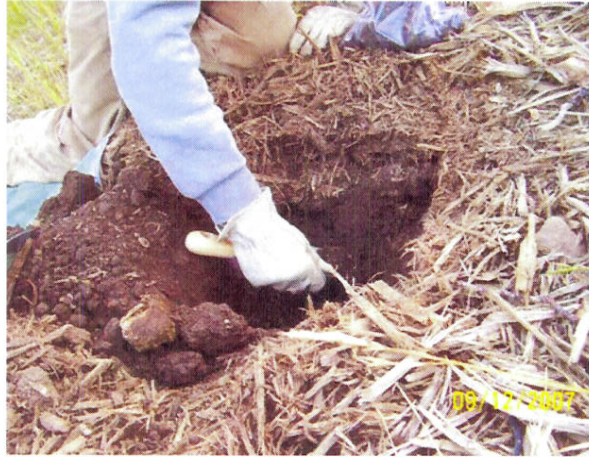
In 2006 and 2007, soil sub-samples were collected from beneath the mulch layer to a depth of 12 inches (30 cm) (Figure 17) at each of the plots that were

Figure 17. Soil sub-sample collection.

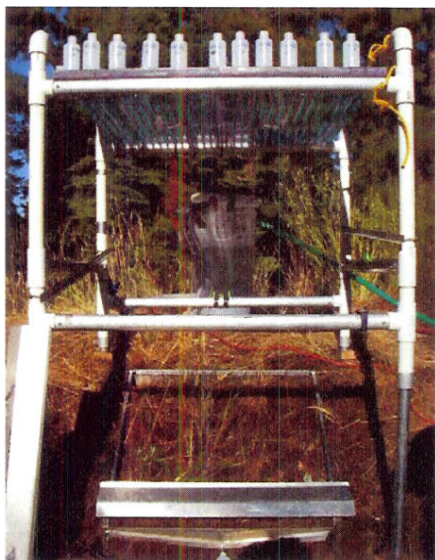
The rainfall simulator “rains” on a square frame from a height of 3.3 feet (1 m, Figure 18 and Figure 19). The rate of rainfall is controlled, and the runoff is collected from a trough at the bottom of the 6.5 square foot (0.6 m²) frame that is pounded into the ground. The volume of water collected is measured; then the volume of infiltration is calculated by subtracting the volume of runoff from the total volume of water applied to the plot. If runoff was not observed during the first 30 minutes, the simulation was stopped. The average steady state infiltration rate was calculated and will hereafter be referred to as “infiltration rate”. The collected runoff samples were then analyzed for the average steady state sediment yield (hereafter referred to as “sediment yield”). Depending on the variability of the plot, one to three rainfall simulations are conducted.

Figure 18. Rainfall simulator and frame.

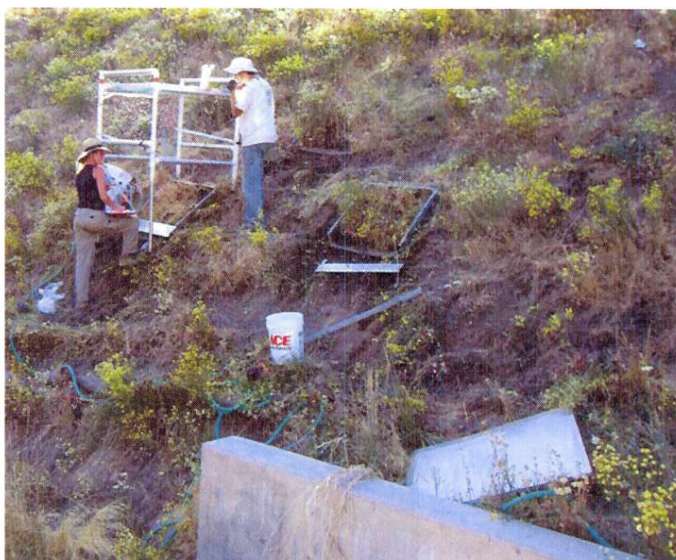
Figure 19. Rainfall simulator in use with frames at the Brockway Fill Slopes Basin #3.
